Following the full survey and documentation of all existing conditions at Building 18 in Magnusen Park for the new Outdoors For All facility, I have prepared the following report. There are two main window types/vintages present. The ground floor and a couple of the second-floor windows are of an older and more traditional style of steel window with the predominant windows at the second level appearing to be newer and in not as good condition.

Outdoors for All Window Remediation Summary and Recommendations

BUILDING 18 WINDOW SURVEY

**Rafn- BLDG#18
WINDOW SURVEY**

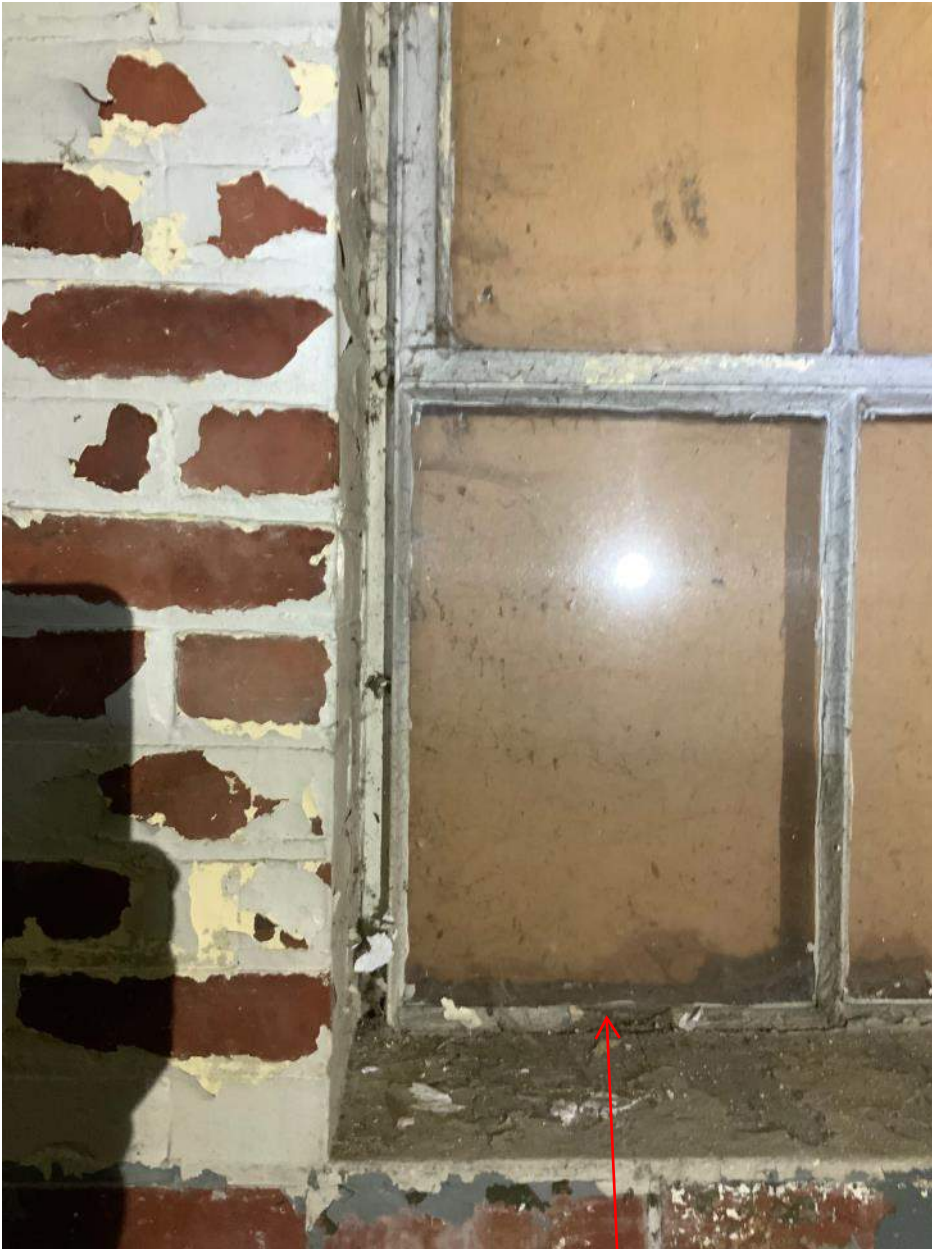
Failing and
Deteriorated Glazing

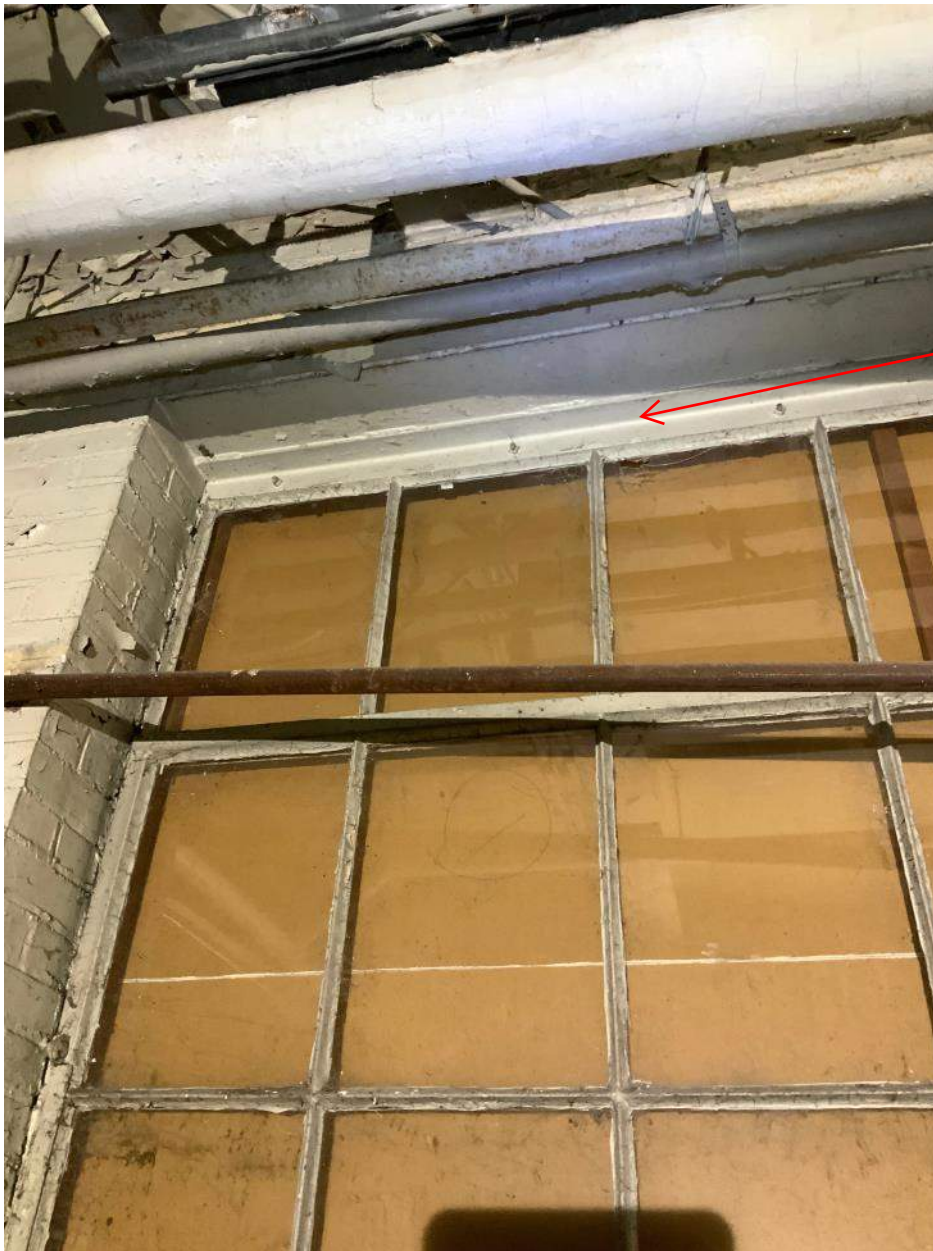
Head detail of sash
reinforced with steel
"L-Bracket"

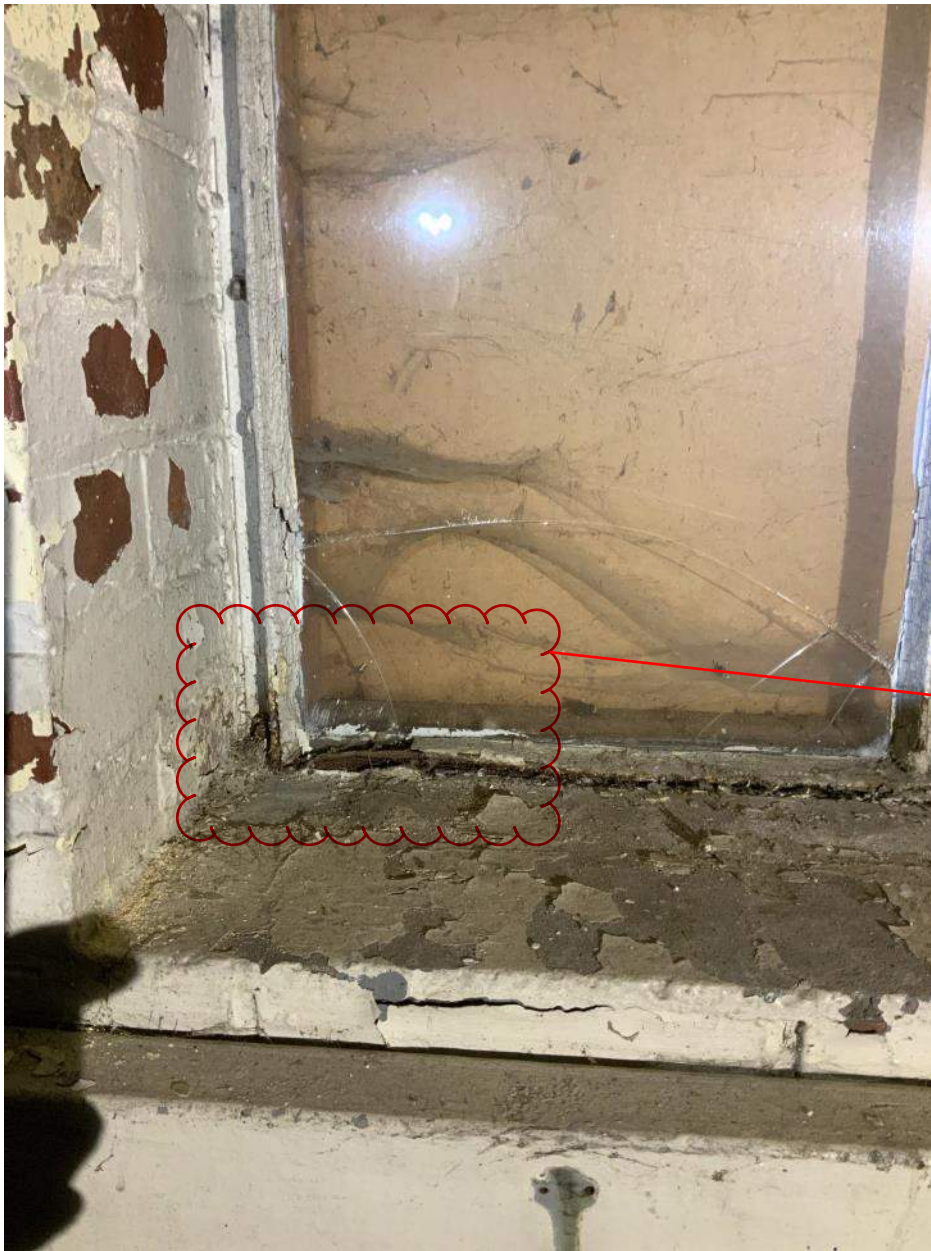
Rust and
deterioration
beginning at left side
of stool.

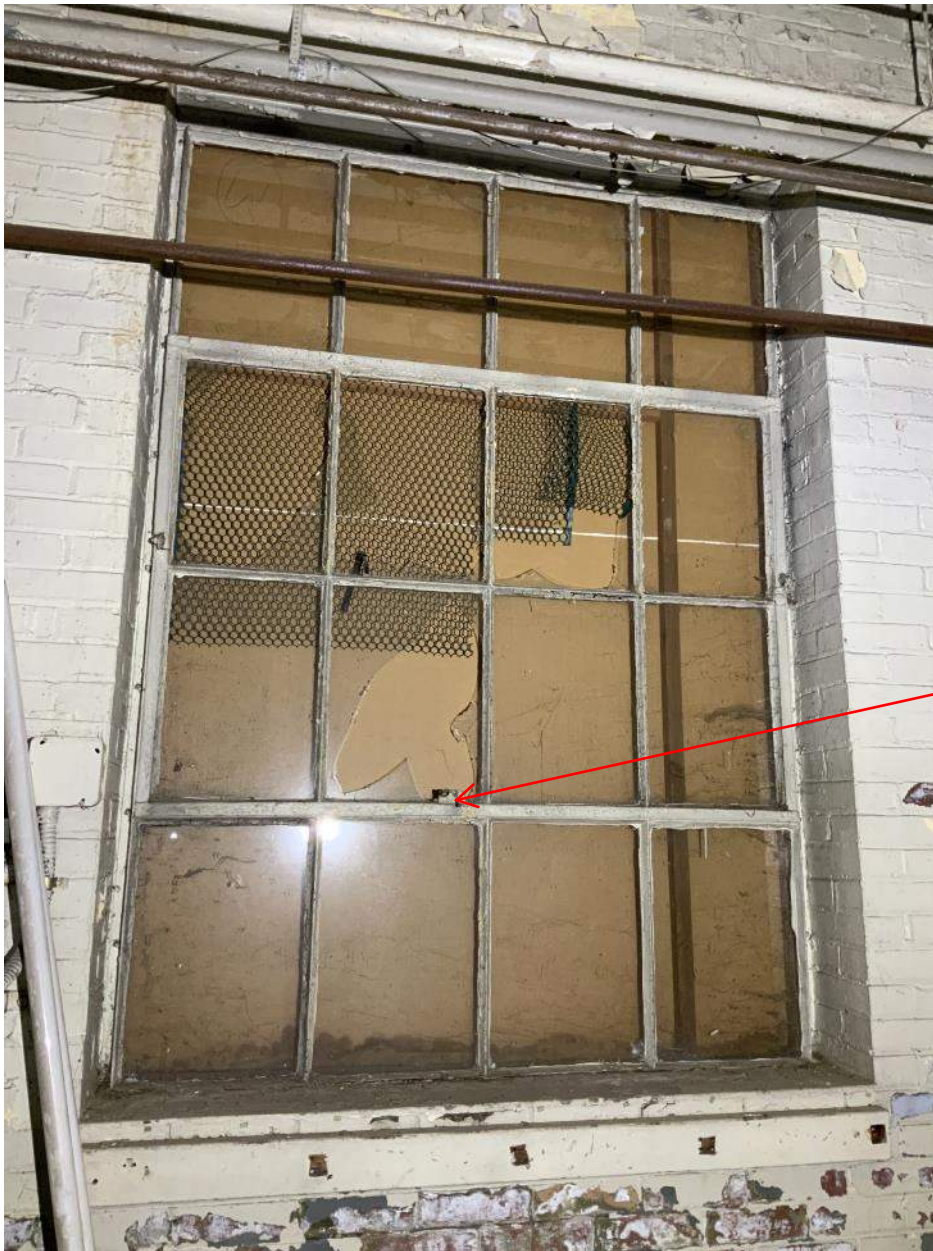
Hardware is
broken/missing

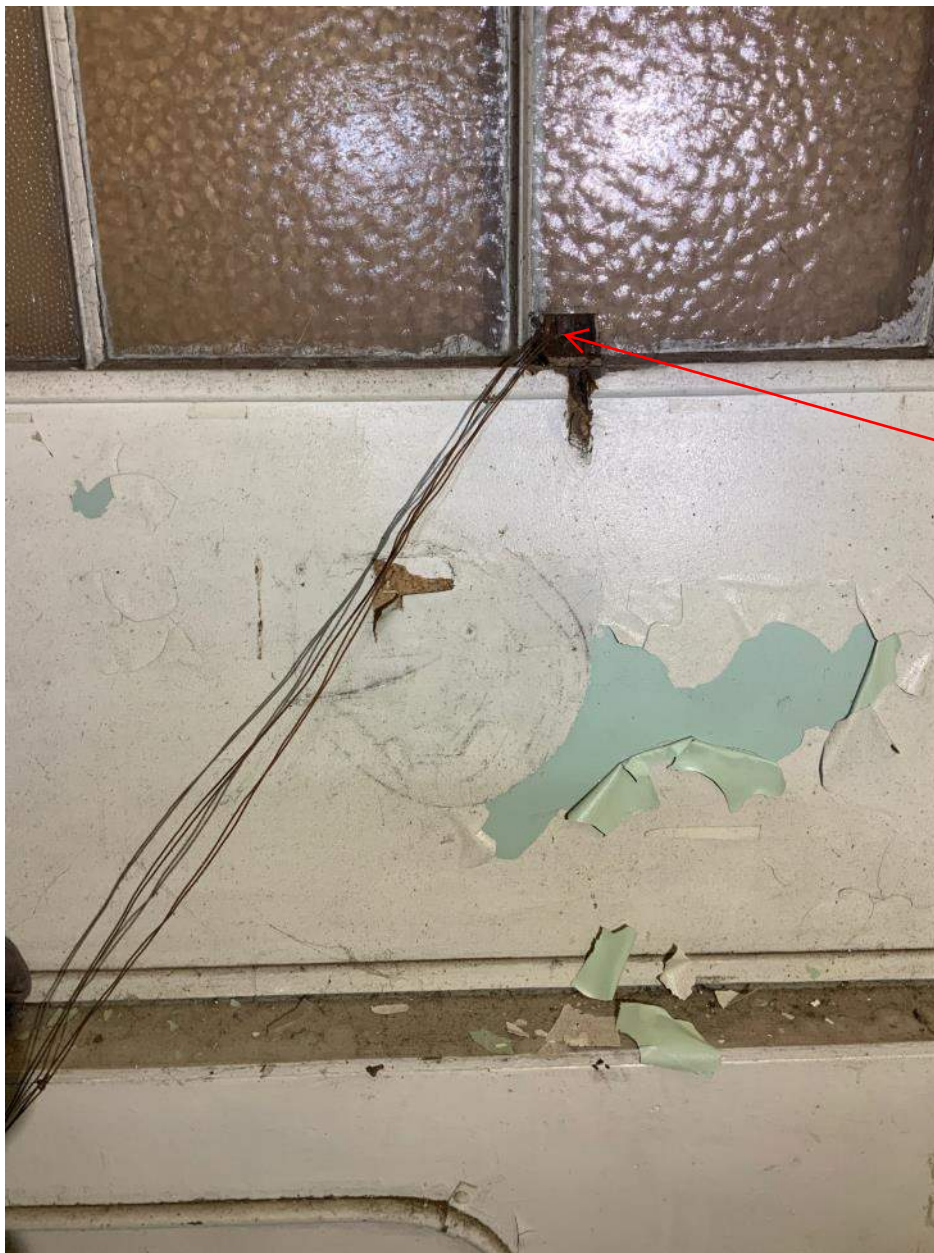
Broken/Missing
Hardware.

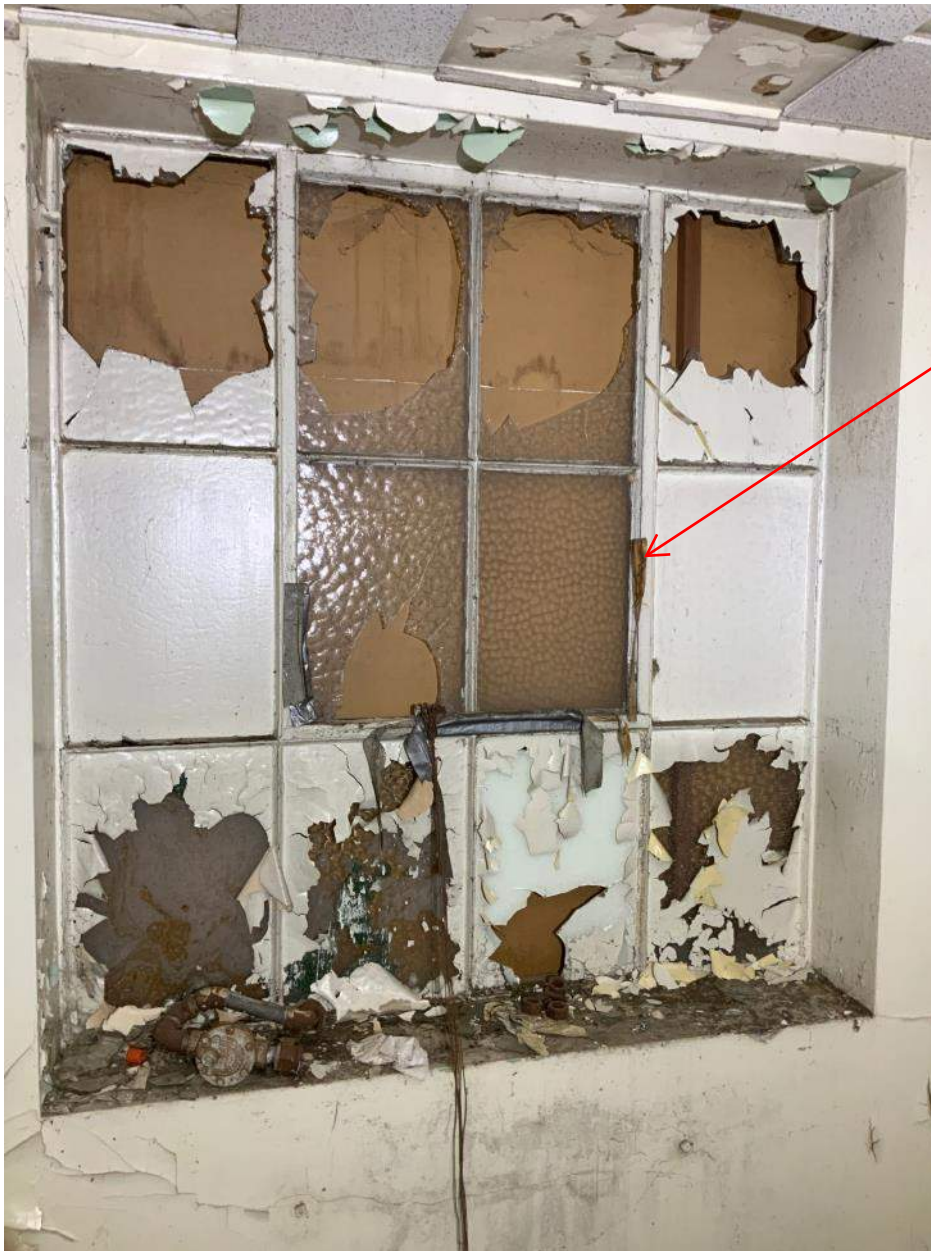
Rust is beginning to
form in the glazing bed

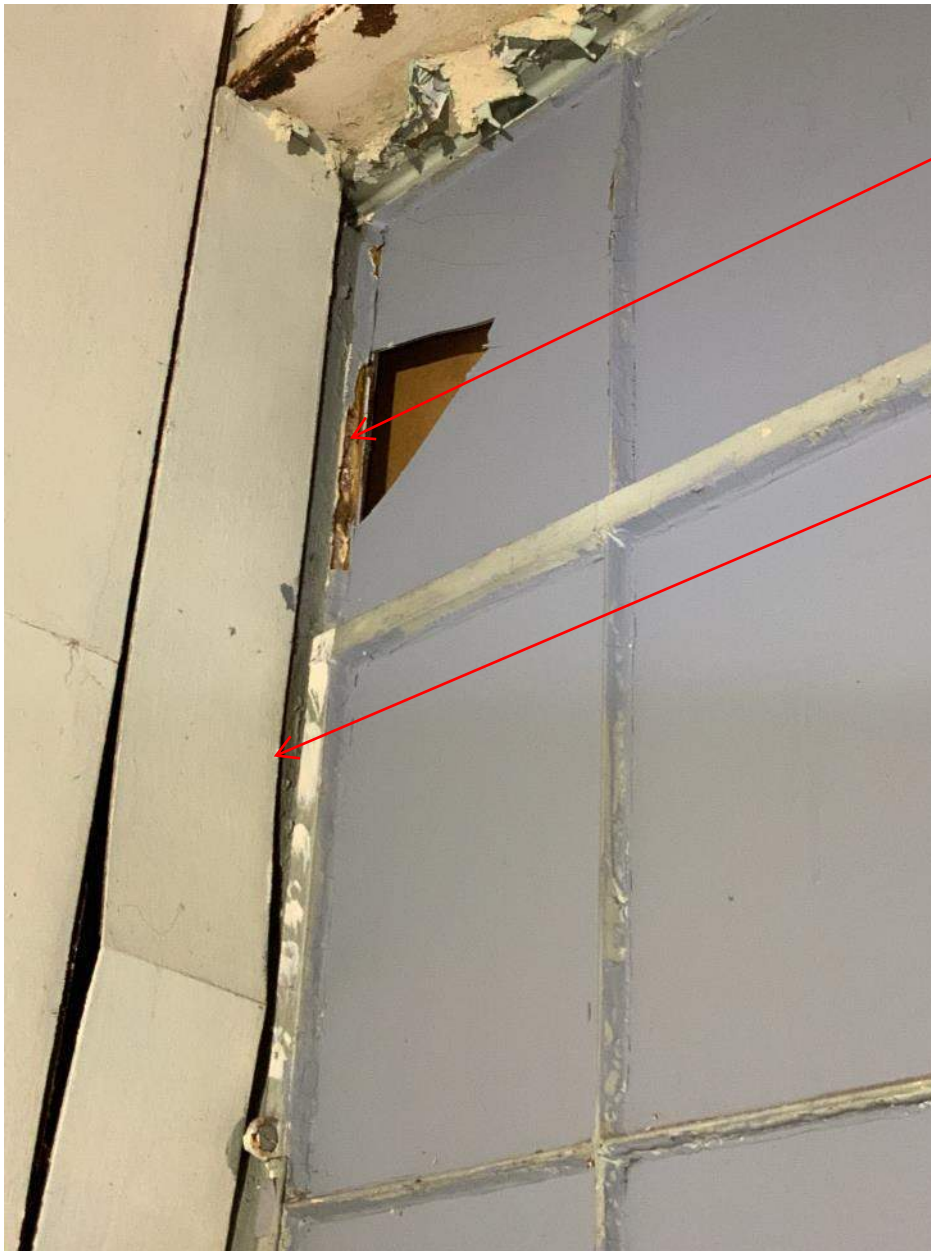
Rust forming in glazing bed

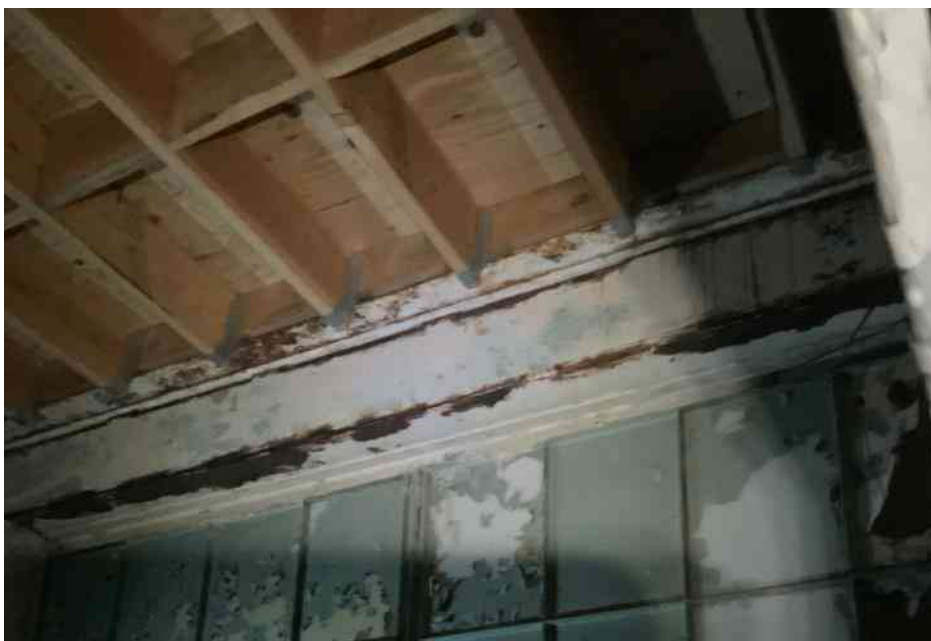
Sash is located directly
inboard of N-1-5.
There is no
salvageable hardware

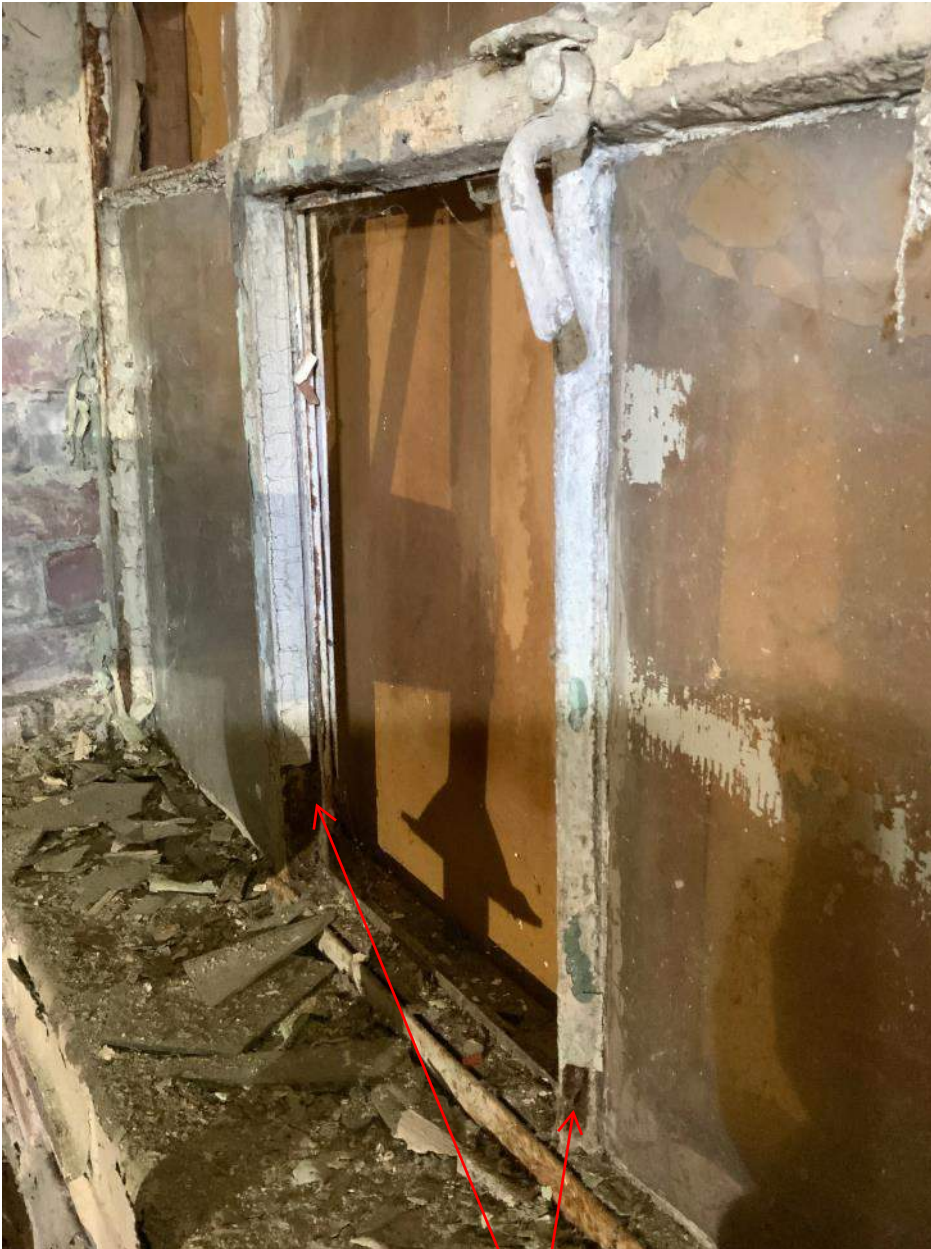
Rust is forming in the
glazing bed. Most
glazing is broken. This
Opening was also left
off of the current
elevations

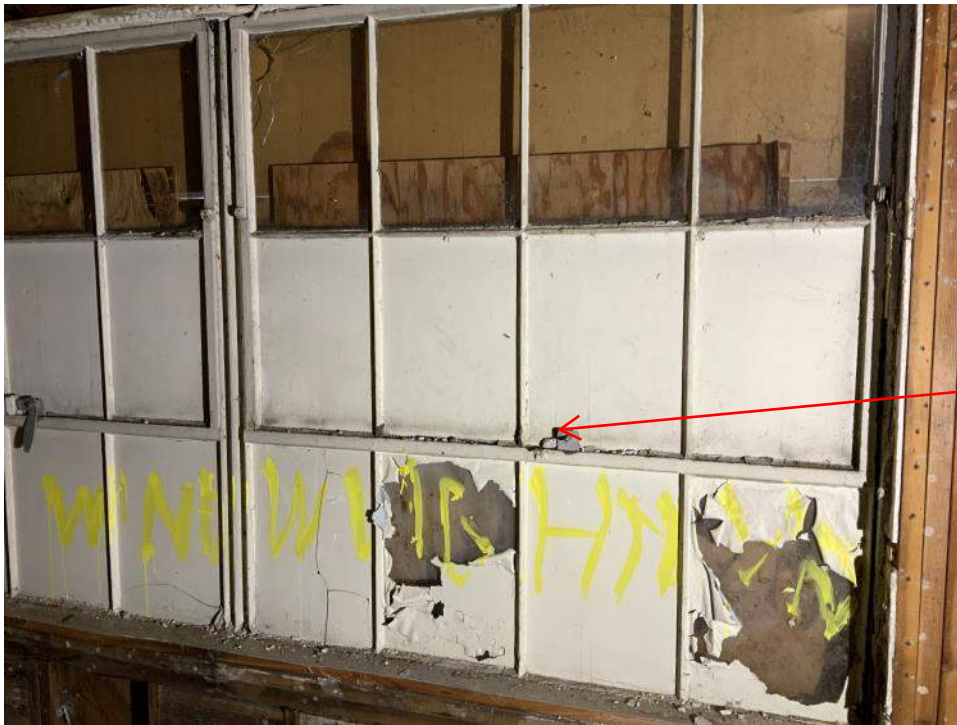
Hardware
missing/Broken

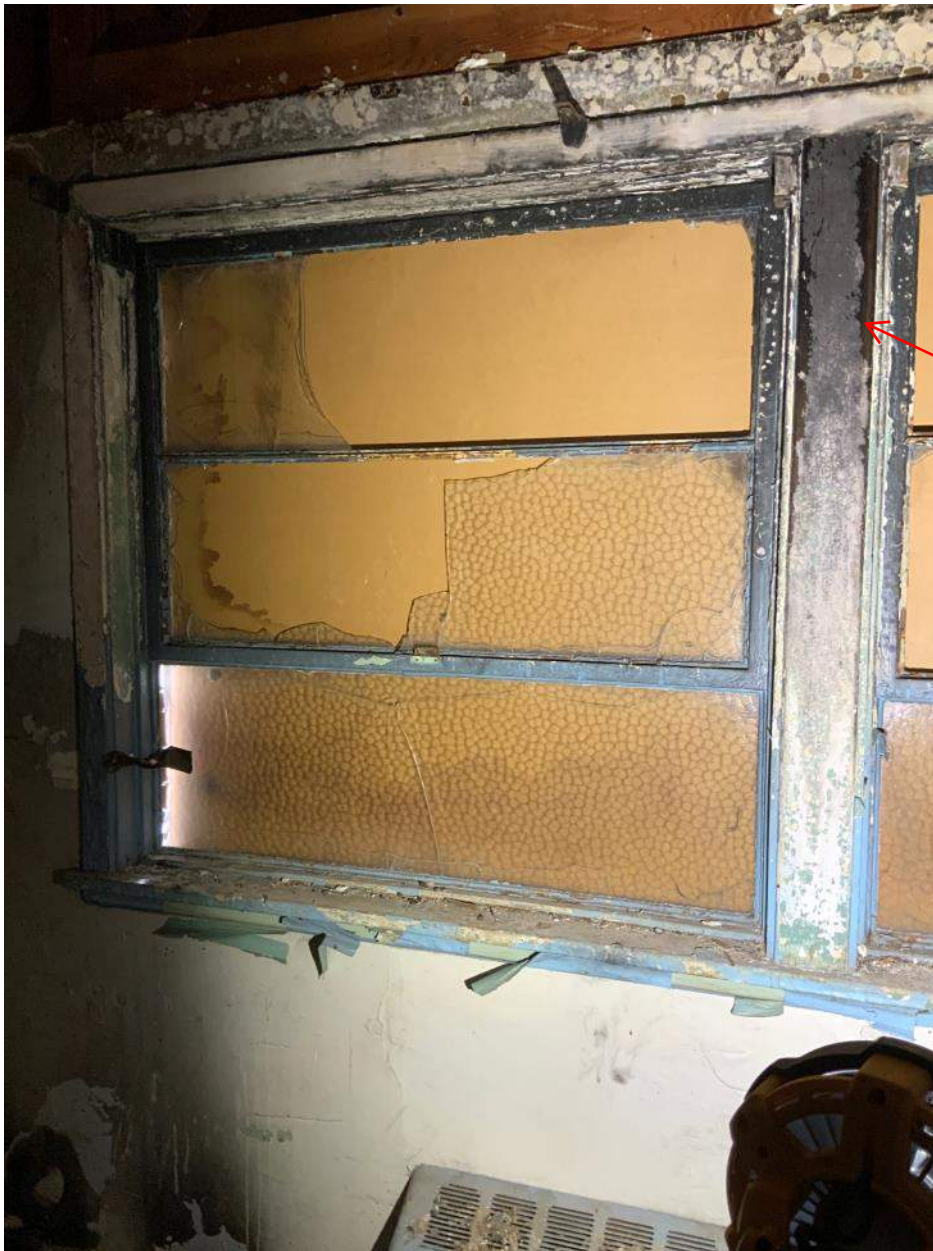
Deterioration at center mullion cap. Rust and pitting are occurring

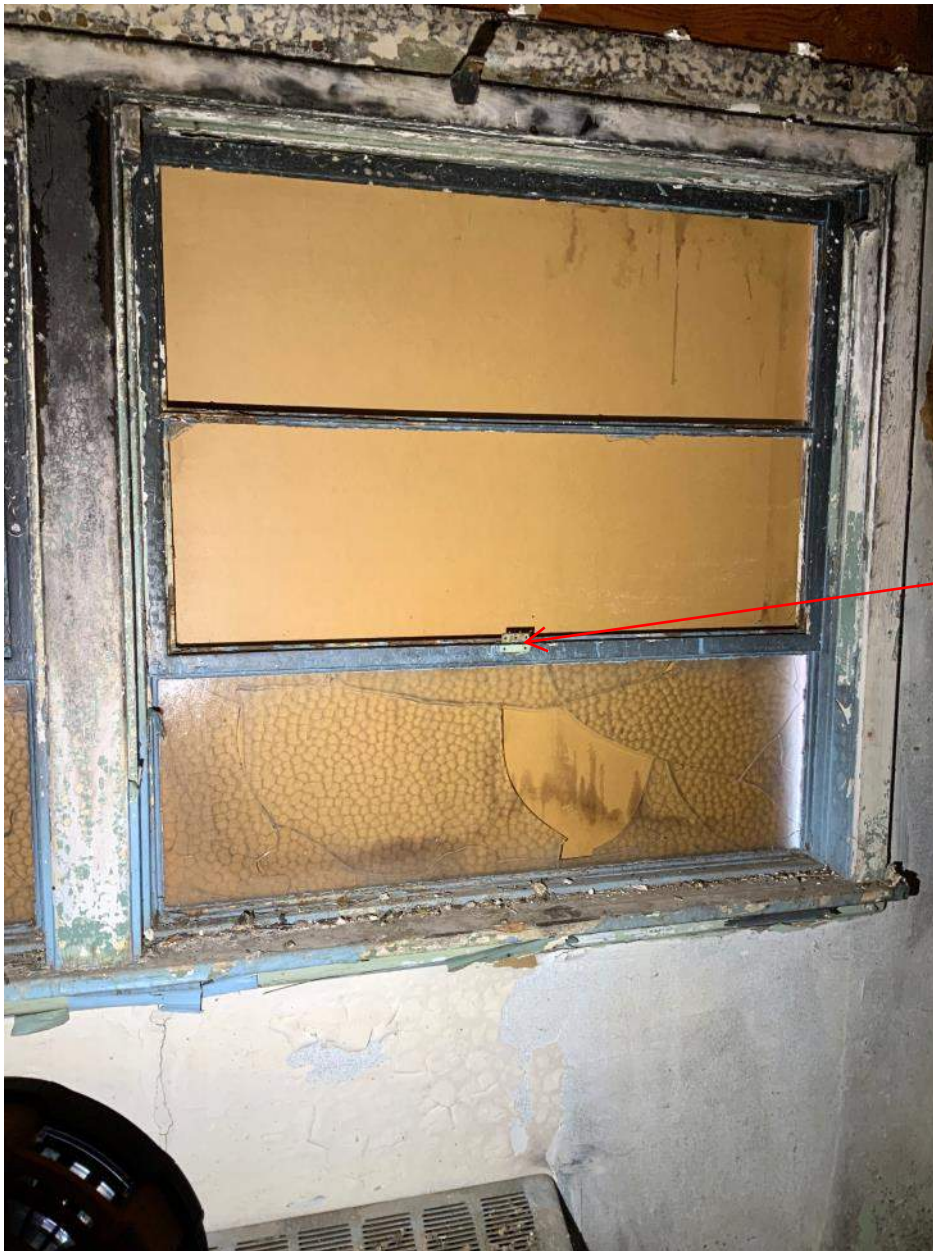
Broken/Missing
Hardware

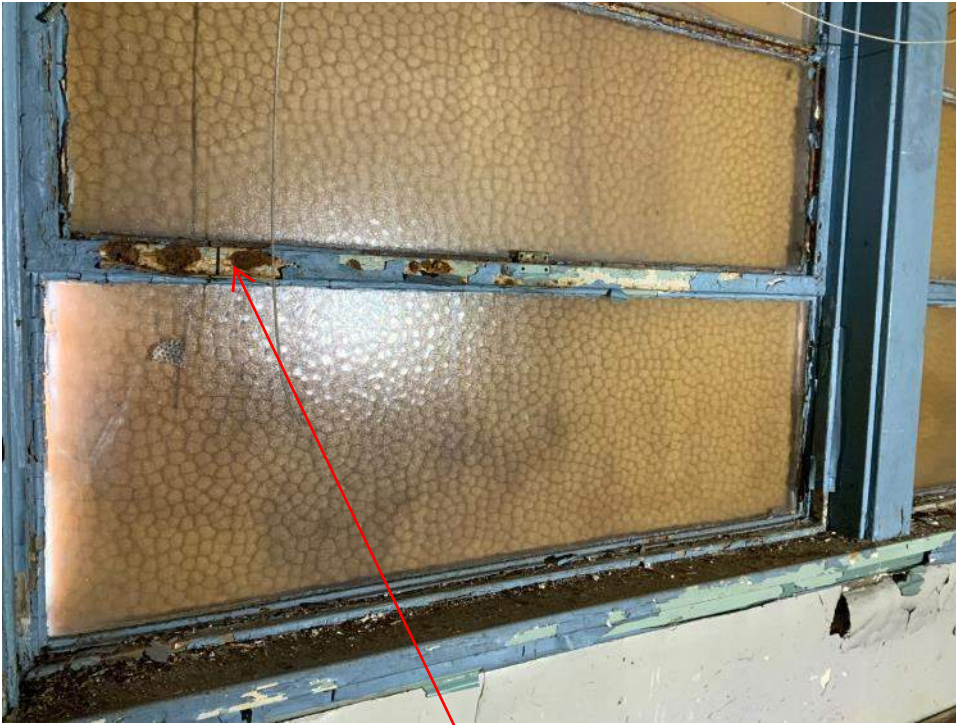
Heavy rust and pitting
occurring at horizontal
meeting rail

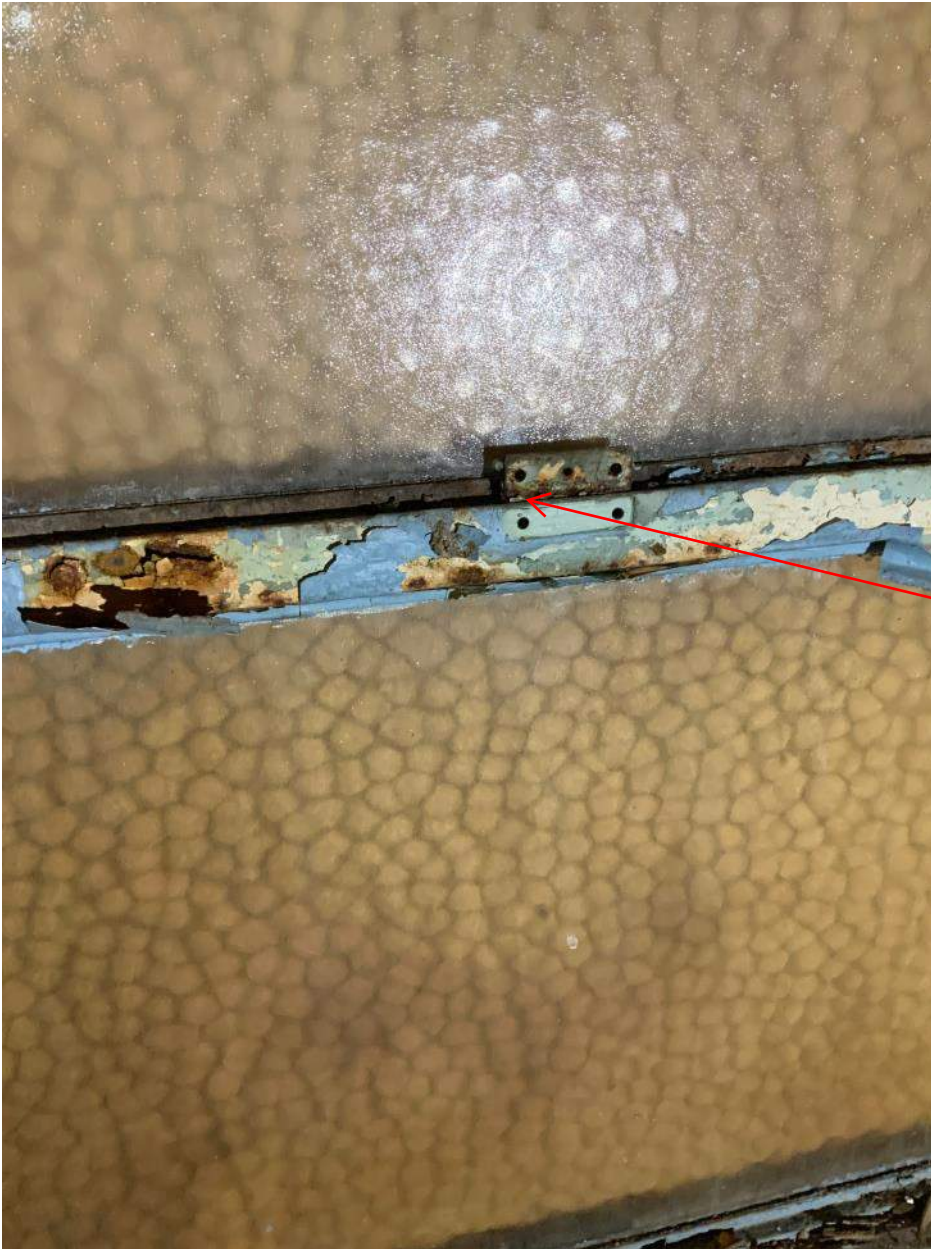
Missing/Broken
Hardware and heavily
rusted

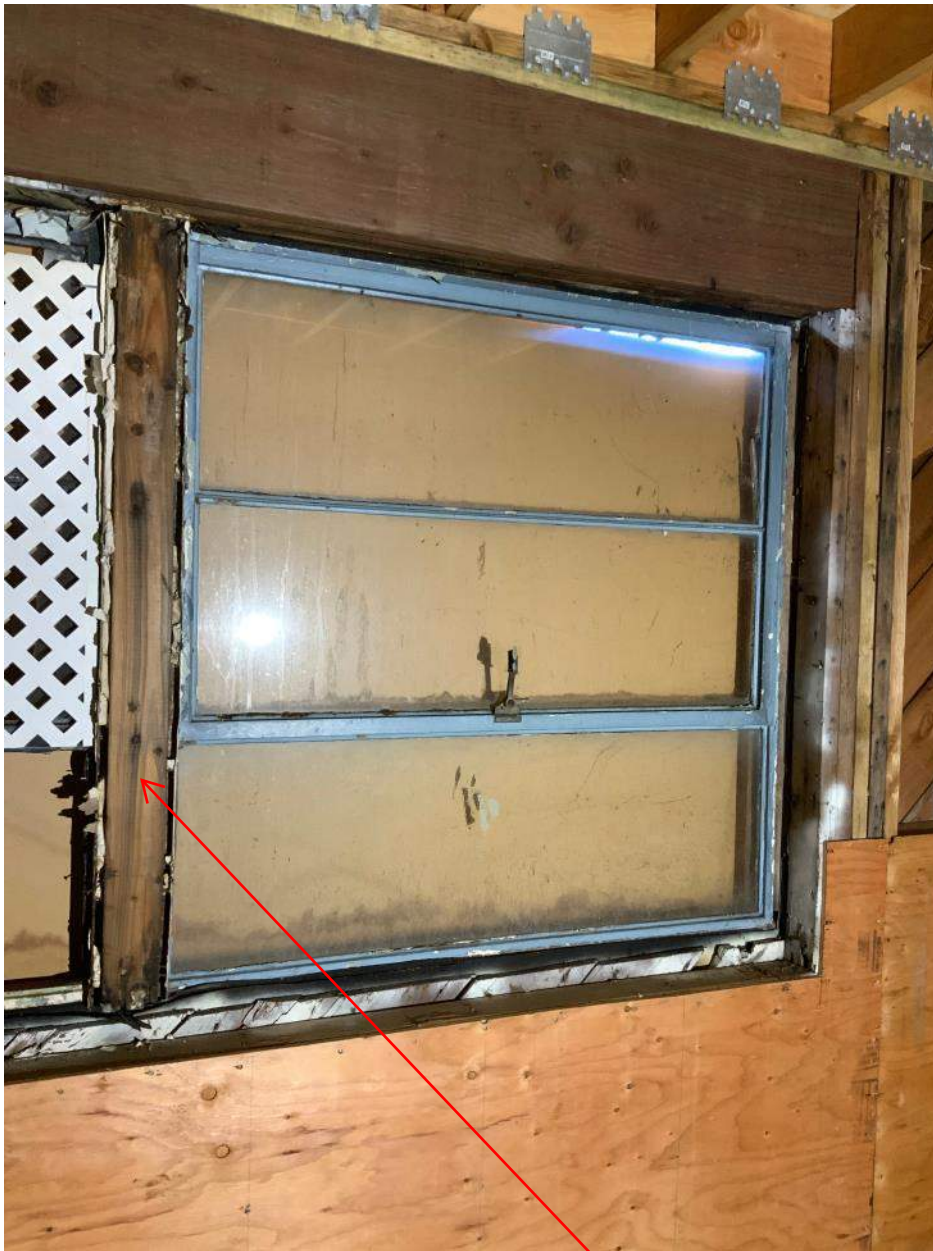
Center Mullion Cap is missing

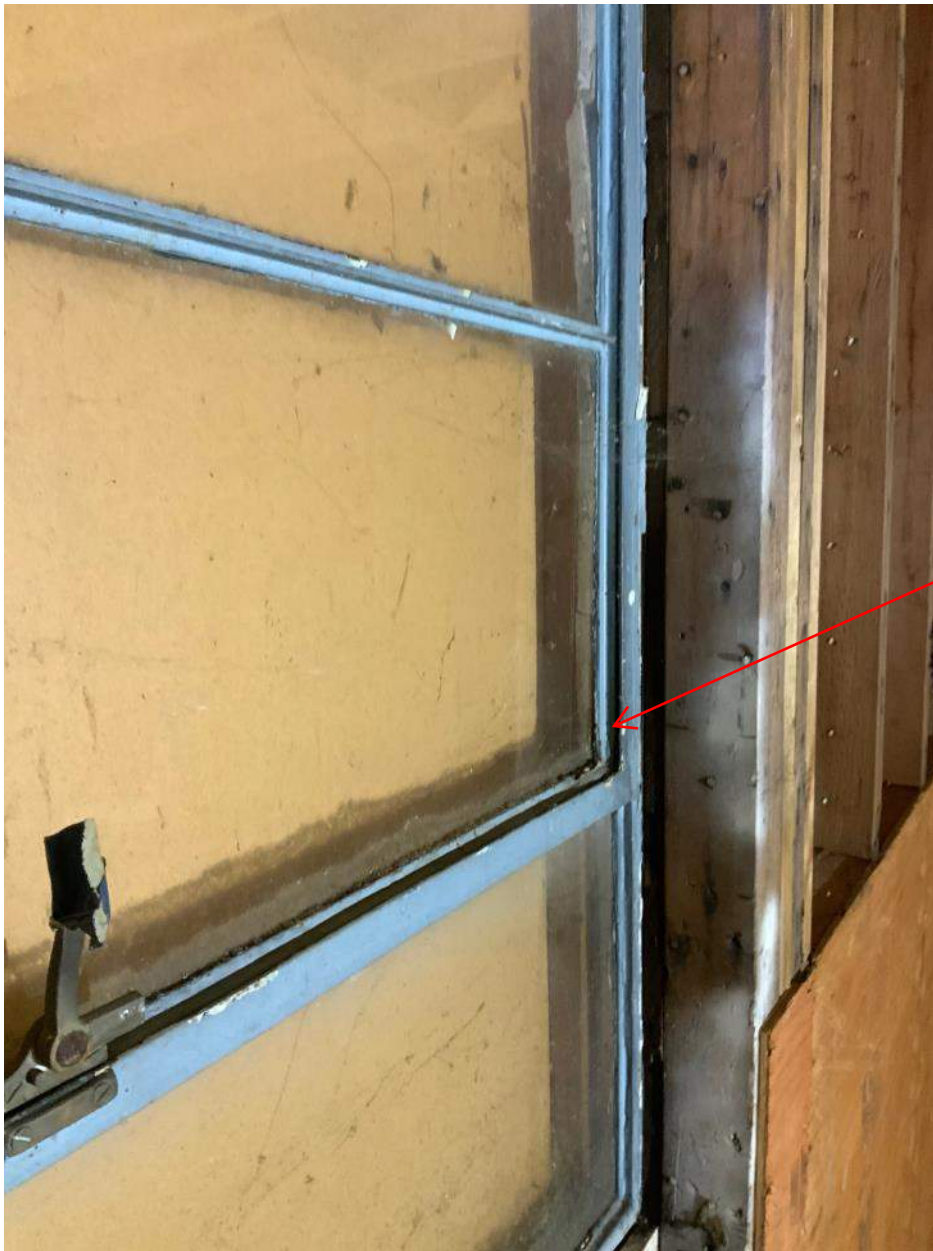
Operator is not fully
seating into frame.

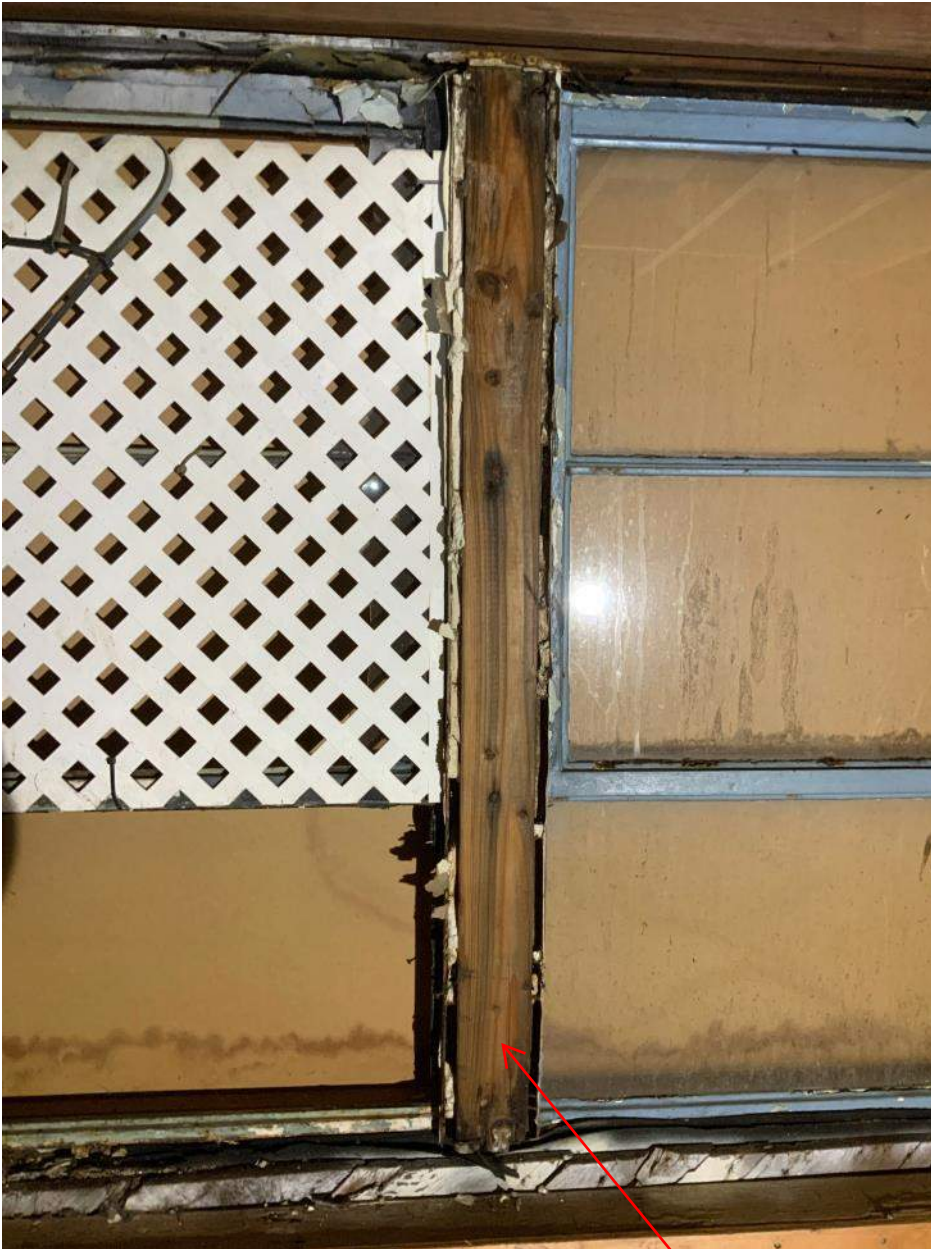
Center Mullion Cap is
missing

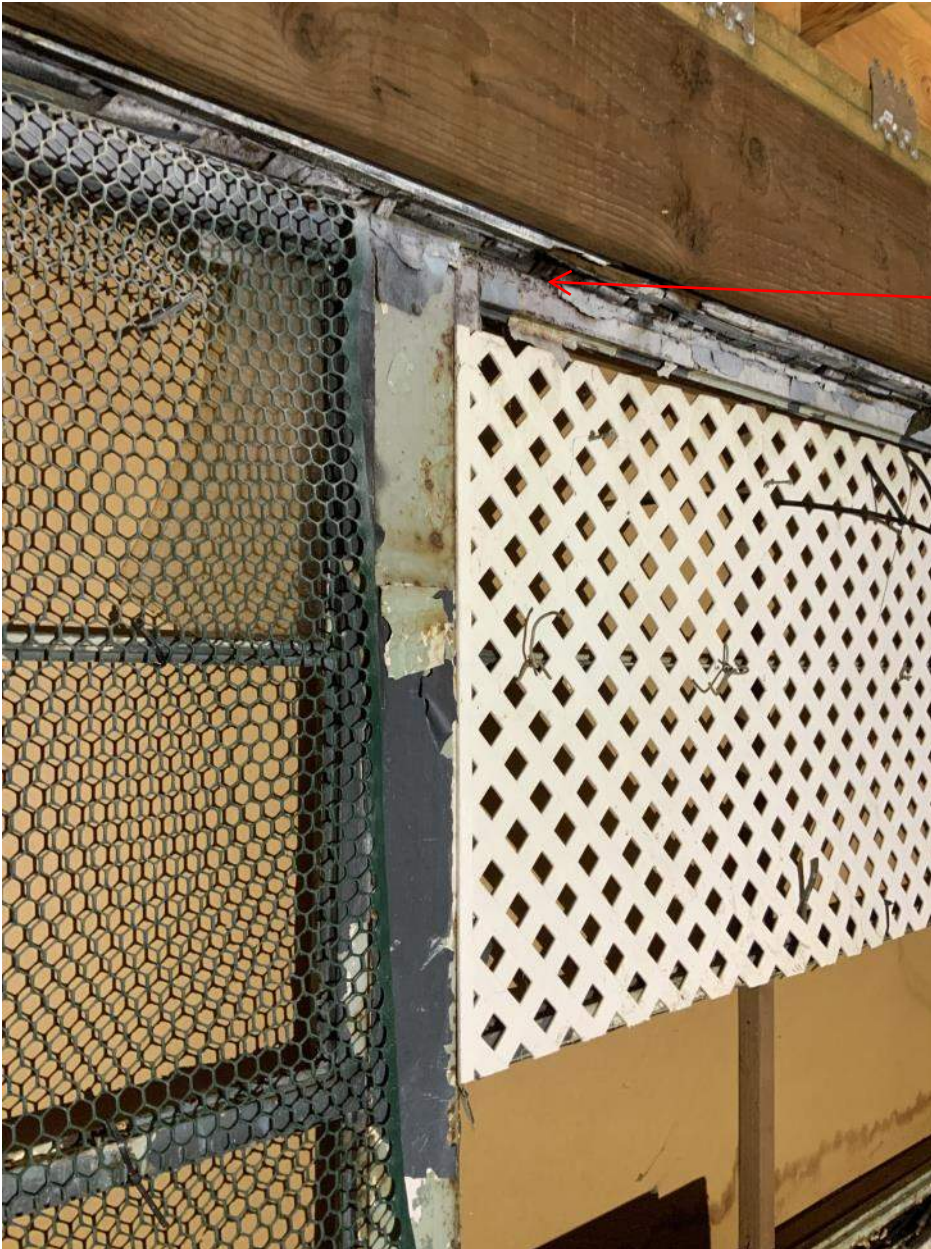
Deterioration occurring
at head of jamb

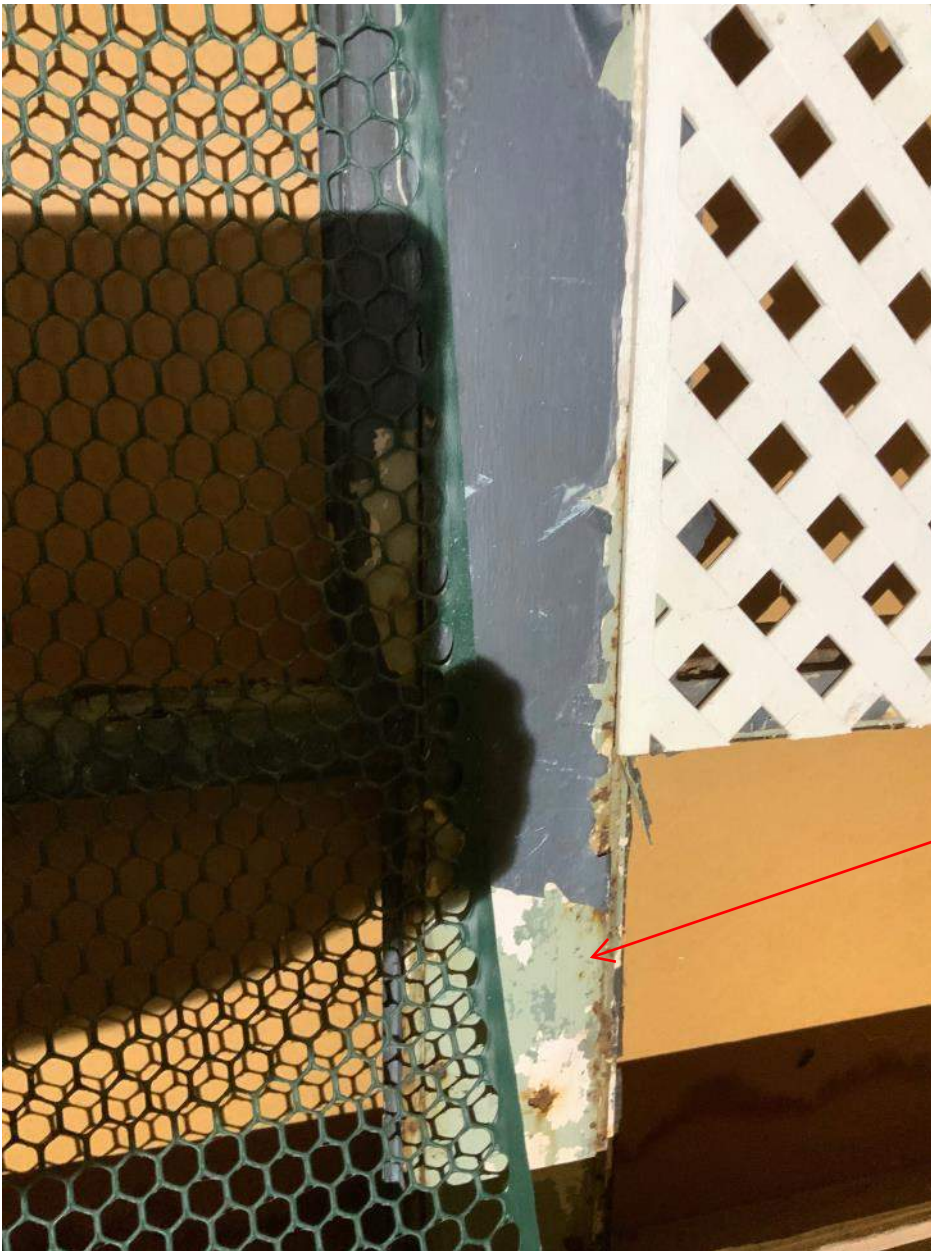
Rust and pitting
occurring at center
mullion

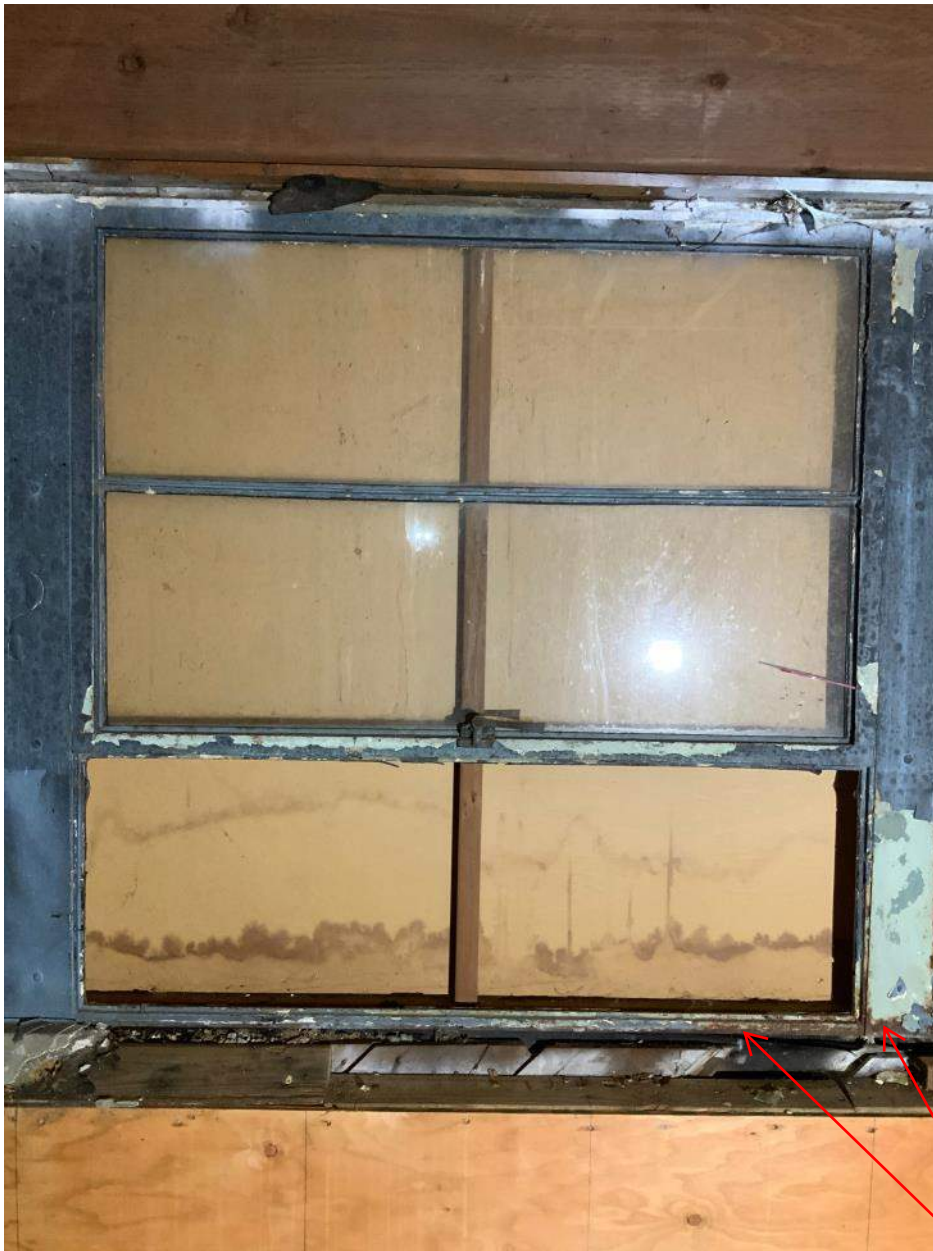
Surface Rust at bottom rail, lower right hand side

Rust and pitting
occurring

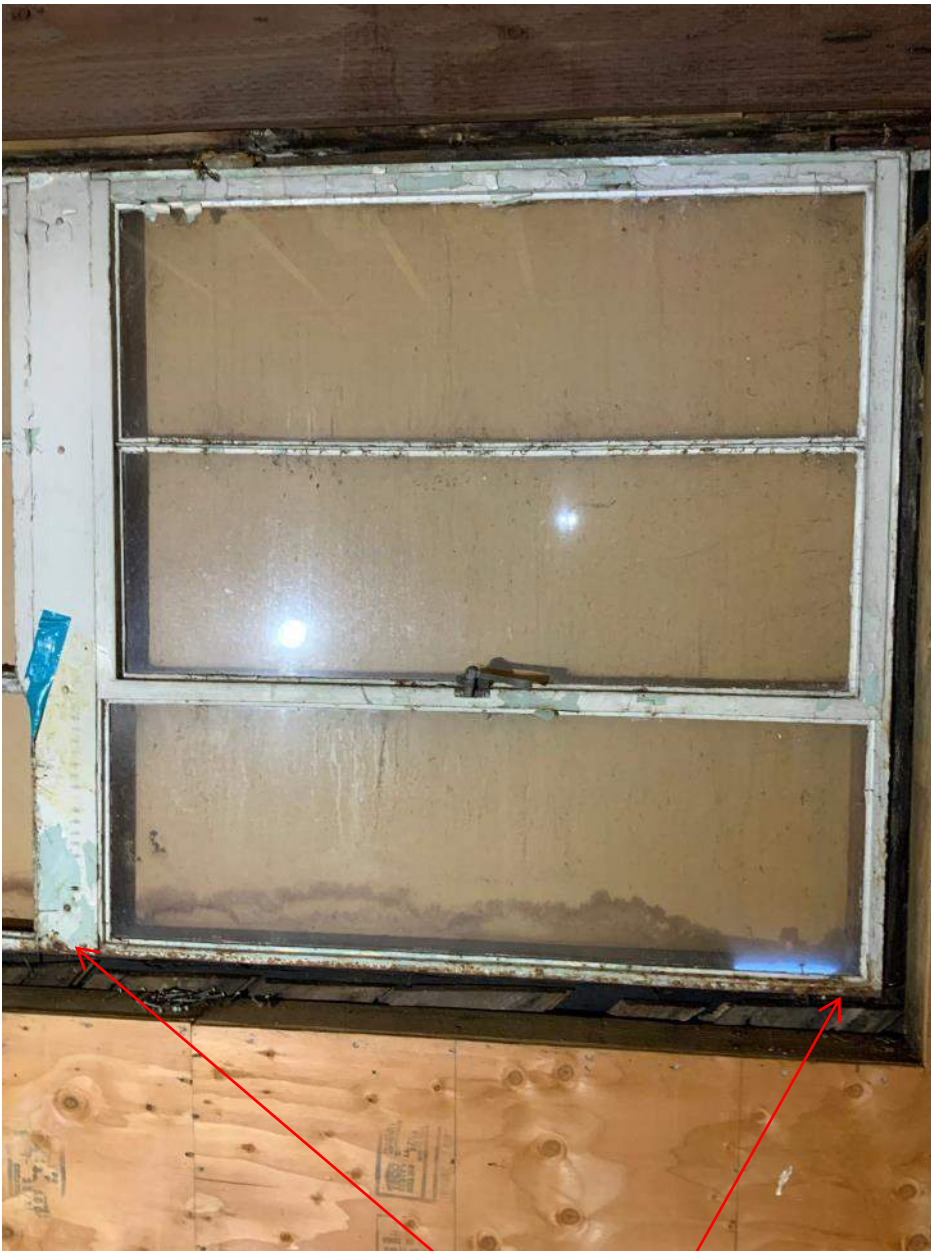
Surface Rust and Pitting Beginning on Bottom Rail and Mullion

Surface Rust and
Pitting
